## BULLETIN

**BEACH EROSION BOARD**

APRIL 1, 1955

### SAND BY-PASSING AT HILLSBORO INLET, FLORIDA(1)

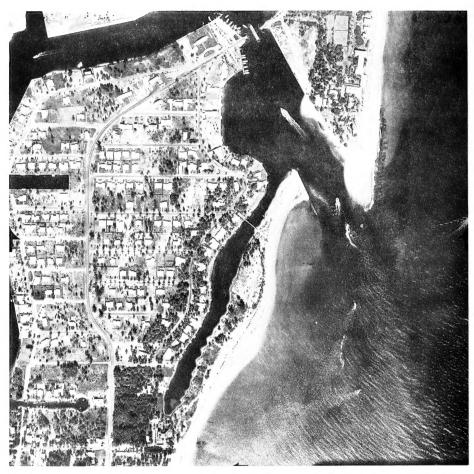
FIGURE 2 · HILLSBORO INLET, FLA.

The aerial photograph (Figure 2) depicts the general features of the inlet. The inlet is protected by a rock reef (as indicated in Figure 3) to the north of the inlet; the reef has a length of 580 feet exposed at mean low water, and at a point 70 feet north of the southern end it is about 68 feet wide and 3.5 feet high above the plane of mean low water. Sections normal to the shore indicate that the top of the reef is convex in shape and relatively smooth. The reef has a gradual slope on the seaward side and a very steep slope on the landward side. The rock reef dips as it crosses the mouth of the inlet, giving a controlling depth to rock of 5 to 6 feet at mean low water. The rock rises again above mean low water level at about 600 feet south of the mouth of the inlet. The southern reef is partially exposed at low water and acts as an offshore breakwater. The high water shore line on the south side of the inlet is in effect about 700 feet landward of the reef line.
